**AN EVALUATION OF GEOMORPHOLOGICAL CONTRIBUTIONS
TO MOUNTAIN HIGHWAY DESIGN WITH PARTICULAR
REFERENCE TO THE LOWER HIMALAYAS**

A thesis submitted for the degree of Doctor of Philosophy
in the University of London

Department of Geography
London School of Economics
and Political Science

February 1987

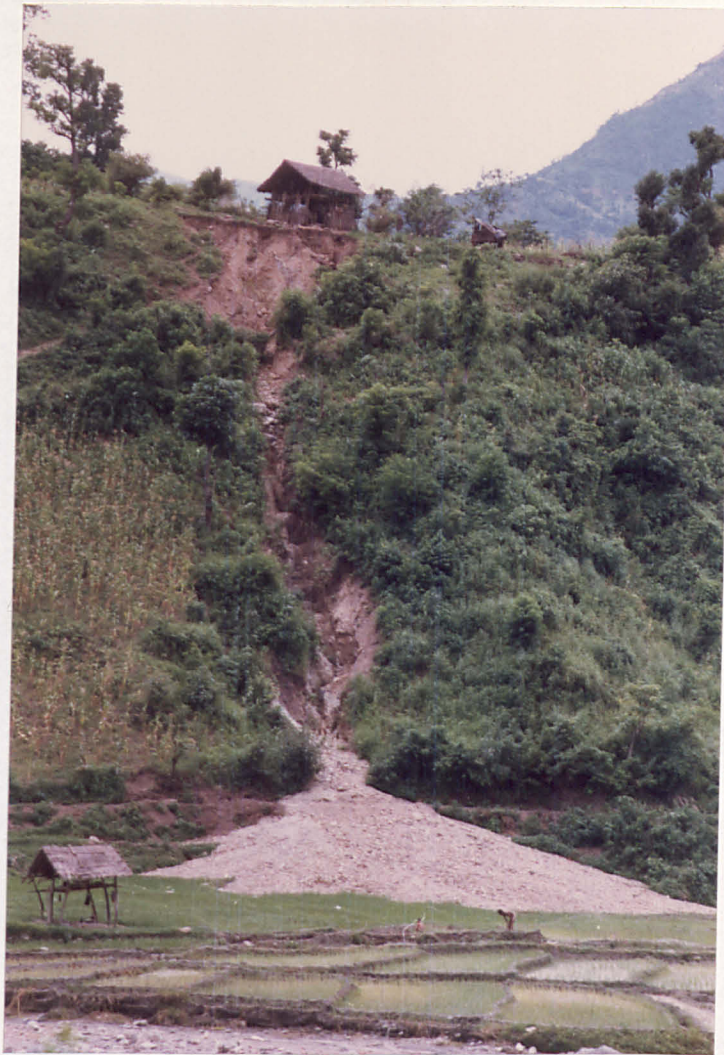
PLATE 2.2 Debris Fan Below Eroding Gully in East Nepal.

bed. In steeply inclined, rocky mountain channels, channel roughness is dominated by an often highly irregular, boulder-strewn channel. Storm runoff is therefore non-uniform and highly turbulent and, consequently, bedload and suspended load are almost inseparable. Sediment is often transported through the channel network in surges or pulses (Gardner 1986), in response to temporally and spatially discrete debris inputs to the channel and unsteady flow. During flood recession much of the transported material becomes deposited in channels, on floodplains and in debris fans at sharp concave breaks of slope in the channel profile, usually on trunk valley floodplains (Plate 2.2) and along the mountain front.

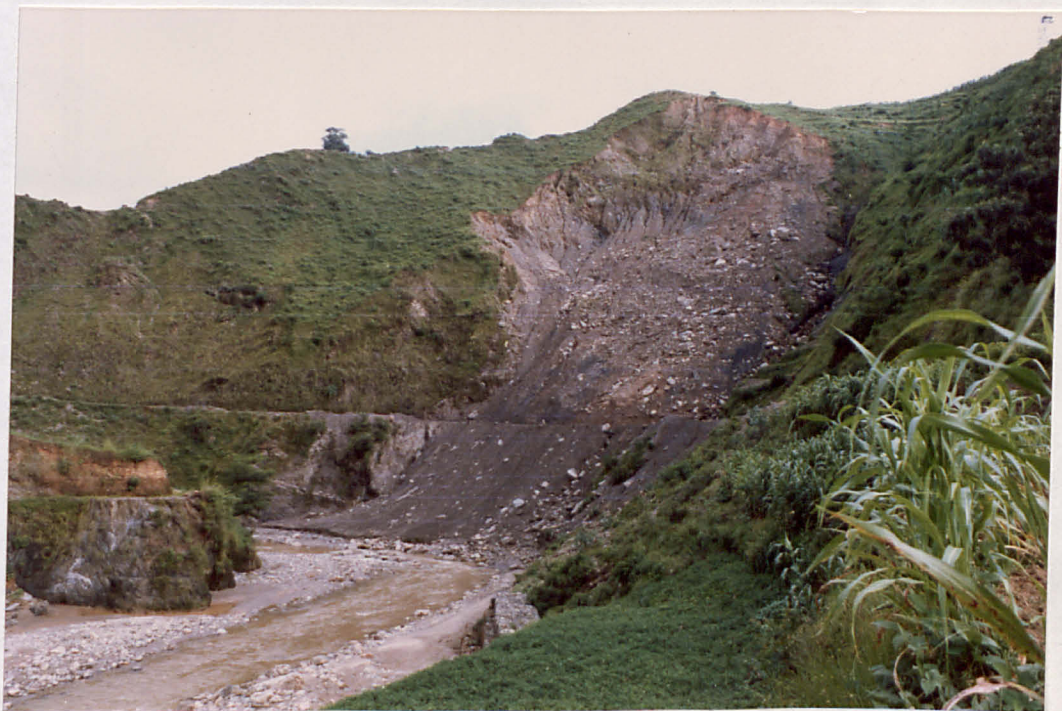
PLATE 2.3 Renewed Instability on Meander Bend Along the Kathmandu-Kodari Road, Reactivated by Road Excavation.

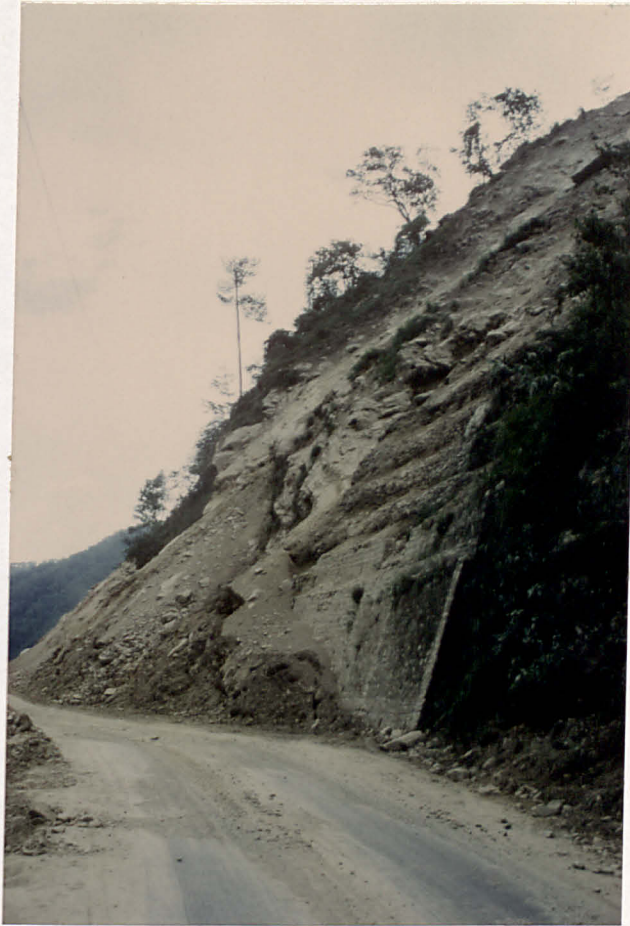
PLATE 2.4 Slope Failure in an Oversteepened Cut Slope in Quartzite Along the Dharan-Dhankuta Road.

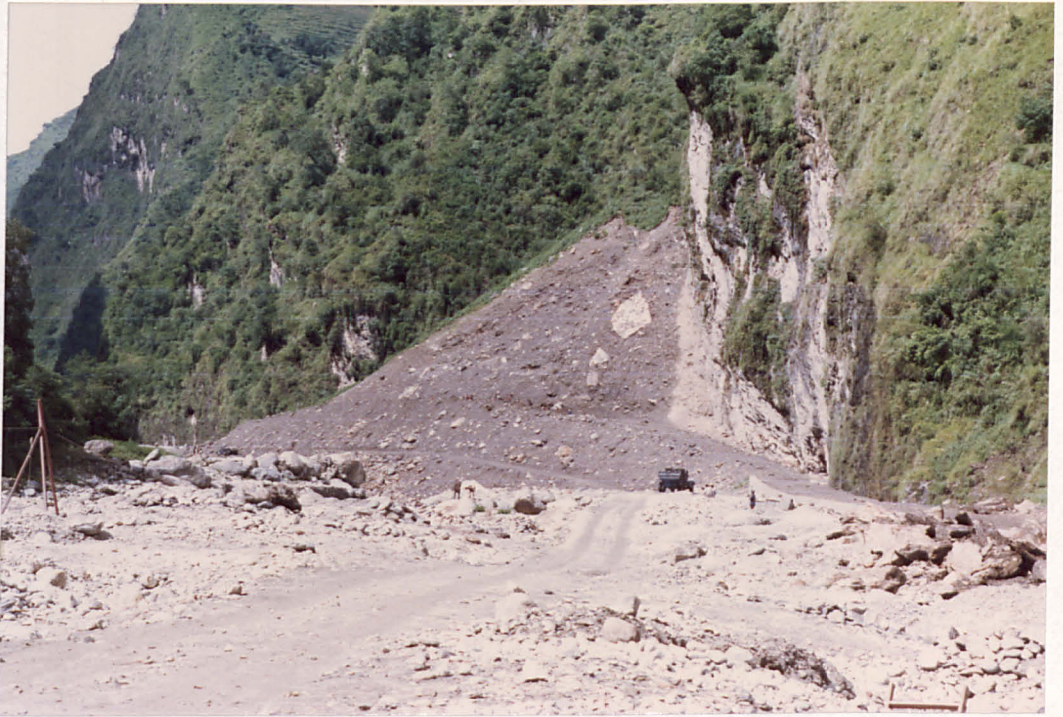
PLATE 2.5 Debris from Large Translational Failure Engulfing Part of the Kathmandu-Kodari Road.

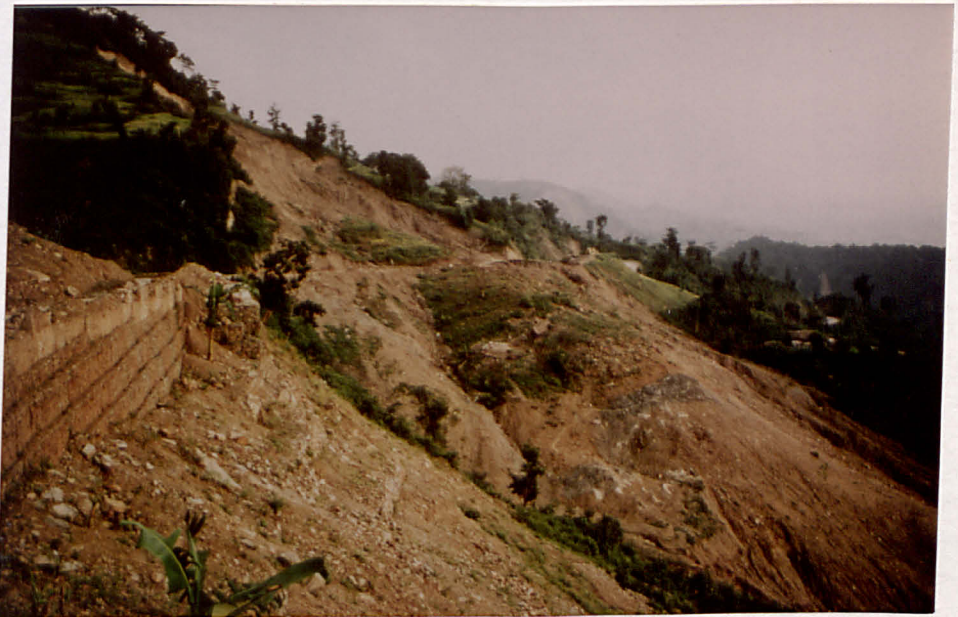
PLATE 2.6 Large Rotational Slide Along the Dharan- Dhankuta Road in 1984.

On the opposite, southern, flank of the re-entrant, deep-seated rotational failure in September 1984, involving some 10^5 - 10^6 m³ of material, destroyed approximately 100m of road line (Plate 2.6). The remedial measures employed on this slope are described in Chapter 4 (Section 4.5). These include surface masonry and subsoil filter drains, dry stone revetments, gabion cut slope retaining wall and erosion protection works (wire meshing of the landslide back-scar together with contour wattling and turfing, to encourage vegetation). Table 2.4 lists the items of work undertaken in connection with road reconstruction (although not surfacing) and slope remedial measures, along with the quantities and costs incurred. The total cost of these works, including contract, labour, materials and miscellaneous items amounted to NCRs 1 047 558 (£43 648 prior to NCR devaluation).

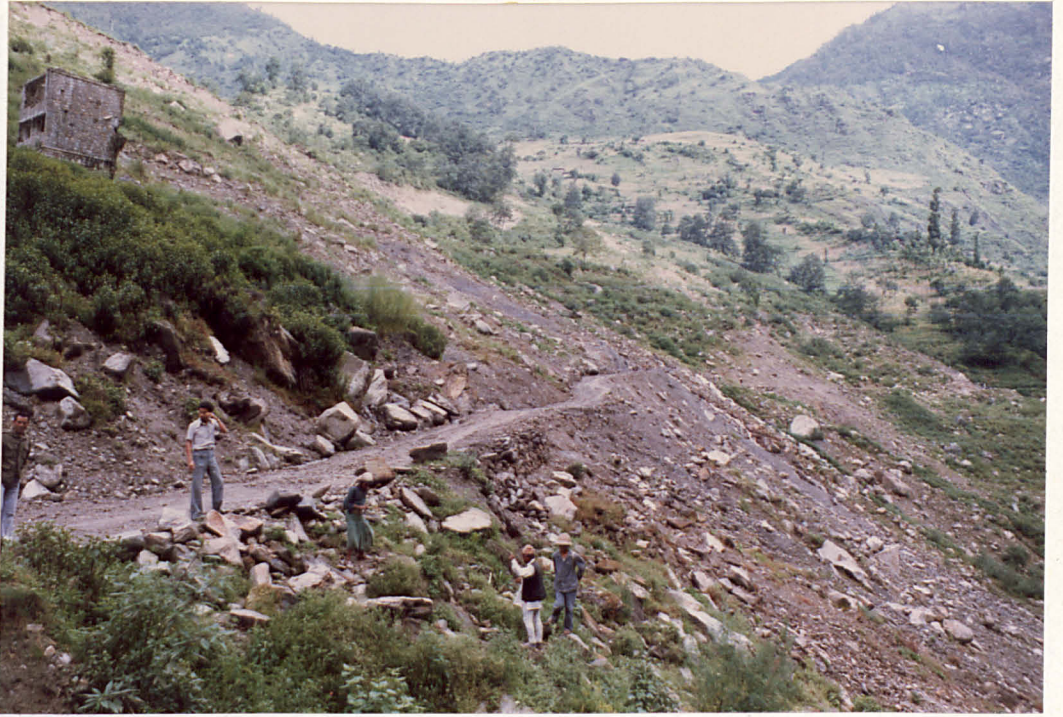
PLATE 2.7 Rotational Slope Failure Causing Gradual Slope Displacement Along the Kathmandu-Kodari Road.

may result. Rapid, catastrophic slope displacement will usually cause total loss of the section of road affected, while gradual, progressive slope displacement may result in slow but continual road surface deformation and subsidence. In the latter case, the slow rate of movement may allow corrective measures, such as toe protection and slope drainage, to be undertaken and road access to be maintained. Instances of road loss caused by deep-seated instability have been reported (Table 2.1) on the Birehi-Bodrinath road (Krishnaswamy 1980), the Sonauli-Pokhara road (Khaire 1975) and the Dharan-Dhankuta road. Plate 2.6 shows a deep-seated, rotational failure on the Dharan-Dhankuta road that occurred overnight in September 1984, in response to the development of high groundwater levels and channel erosion following intense and prolonged precipitation. The remains of the road can be seen in the photograph, some 100m downslope of its original position. Didwal (1984) has described the impact of the deep-seated rock slide at Nashri on the Kashmir National Highway No. 1A where the road has been blocked on thirteen occasions for a maximum period of thirteen days. Road subsidence and deformation have been reported along the Gangtok-Sherbathang road (Ayyer 1975), the Chakki-Dalhousie road (Krishnaswamy 1980), the Hardwar-Bodrinath road (Krishnaswamy and Jain 1975), the Gangtok-Chungthang and Gangtok-Siliguri roads (Natarajan *et al* 1980), the North Sikkim Highway (Soin 1980) and the Kathmandu-Kodari road (Table 2.2). In the latter case, road subsidence of 3-5m occurred in 1983 for a distance of 1 km at two locations (Table 2.1 and 2.2, Plate 2.7).

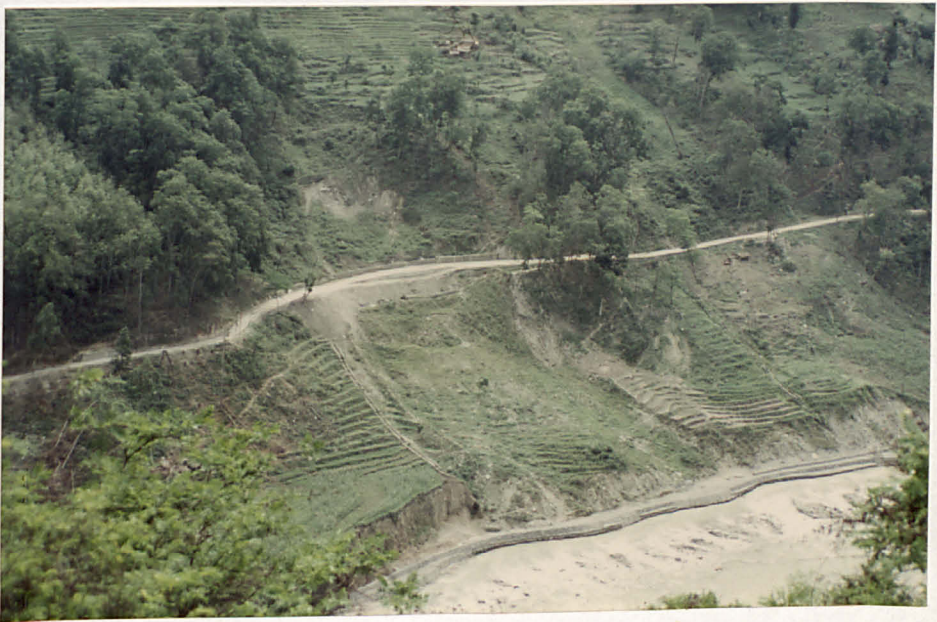
PLATE 2.8 Mudflow and Mudslide Along the Singla-Kalimpong Road.

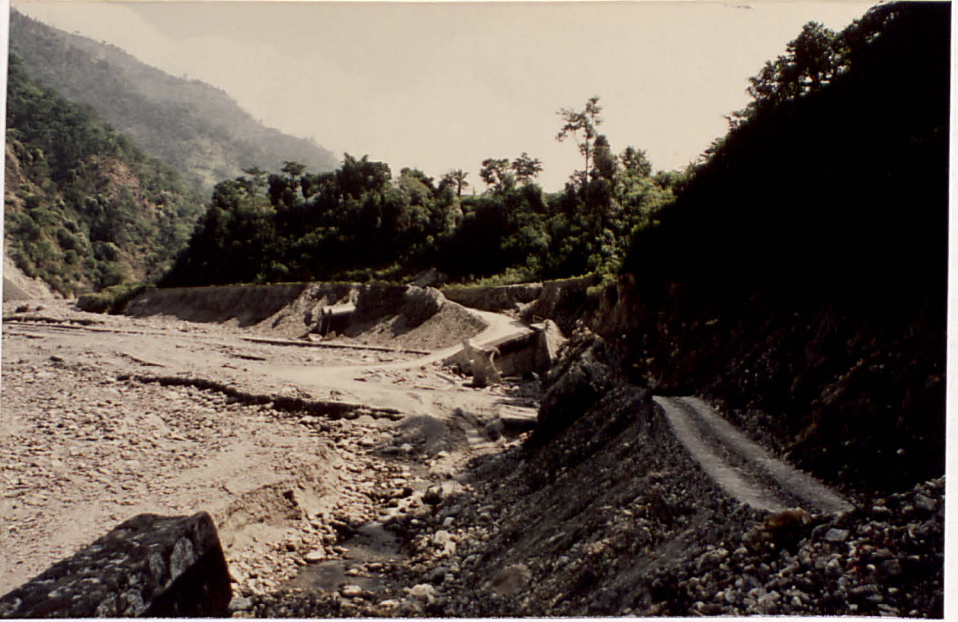
PLATE 2.9 Extensive Damage to the Dharan-Dhankuta Road Caused by Flooding in the Leoti Khola in 1984.

Fluvial hazards encountered by mountain roads include flooding, slope and channel erosion, sediment transport and deposition (Table 2.1). The flood hazard poses a high risk to road stability when the road is located on the floodplain, or when slopes below the road are scoured and undercut by floodwaters. Flooding of the Bhoté Kosi in 1981 destroyed much of the Kathmandu-Kodari road (Figure 2.2) upstream of Lamusangu (Table 2.2) by both direct scour and undercutting from below. The Dharan-Dhankuta road was destroyed at four main locations by flooding in the Leoti Khola during the 1984 monsoon (Plate 2.9), as is described in Appendix 1A.7.

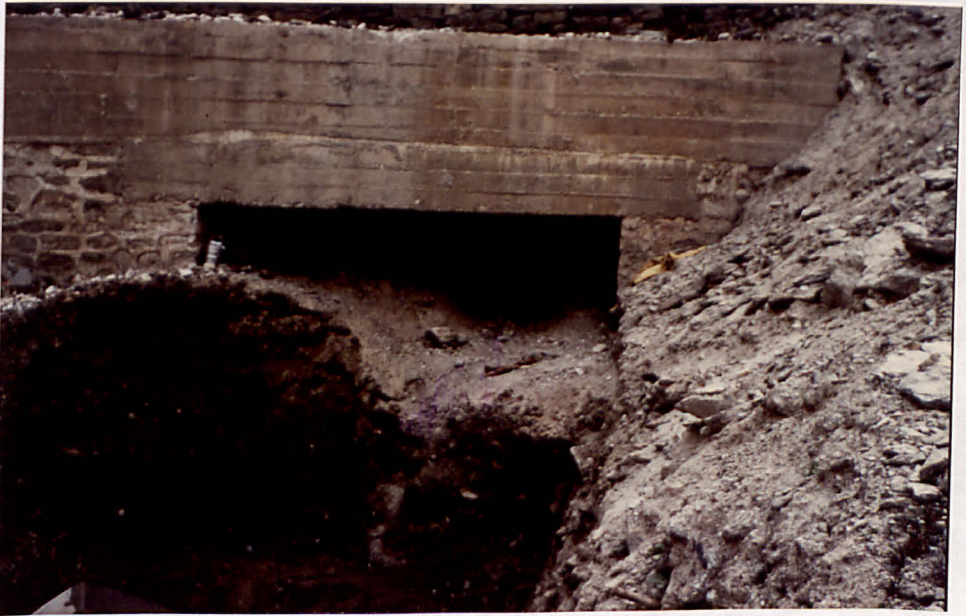
PLATE 2.10 Culvert Blockage Along the Dharan-Dhankuta Road.

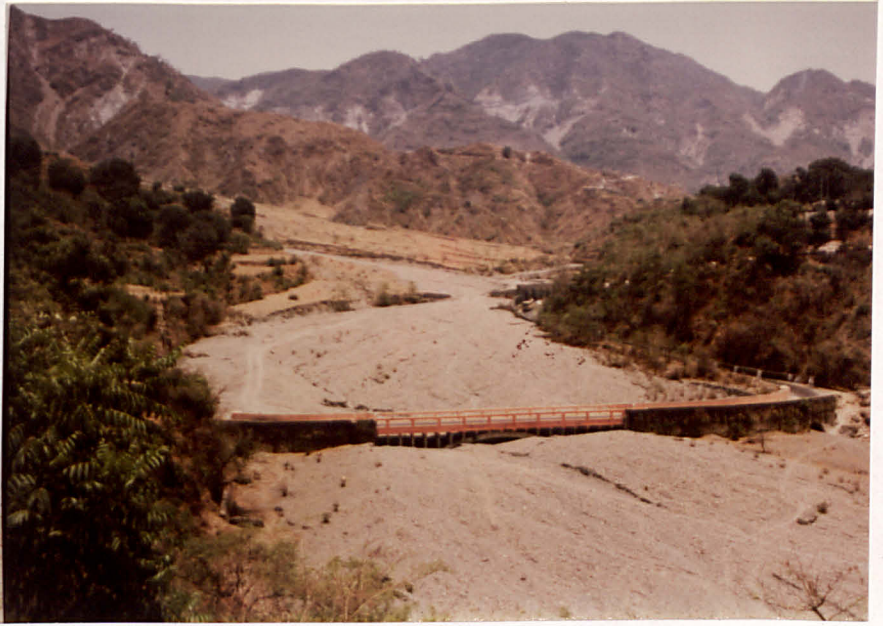
PLATE 2.11 Bridge Inundation by Debris Fan Along the Dehra-Dun-Mussoorie Road.

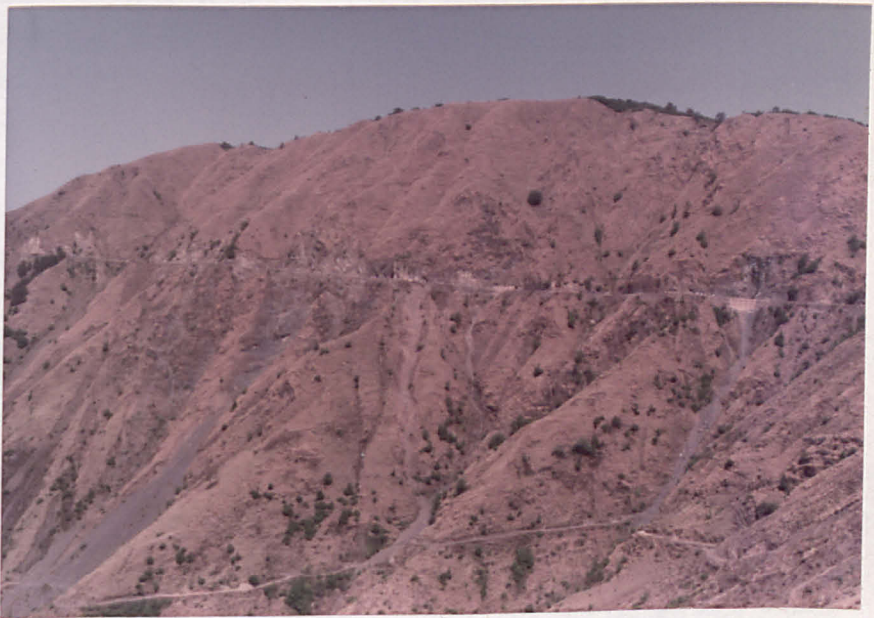
PLATE 2.12 Contoured, Near-Ridge Top Alignment of the Mussoorie-Tehri Road

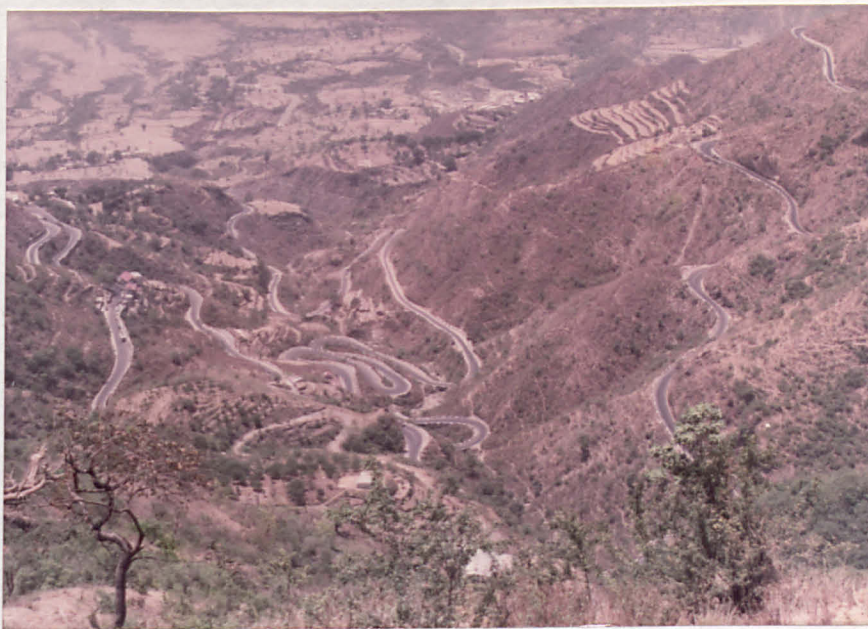
PLATE 2.13 Sinuous Alignment of the Dehra-Dun-Mossoorie Road.

and Nepal (Table 2.2). The resulting alignments tend to be rather complex in design (Plate 2.13), and are often composed of one or a number of hairpin stacks (Plate 2.14).

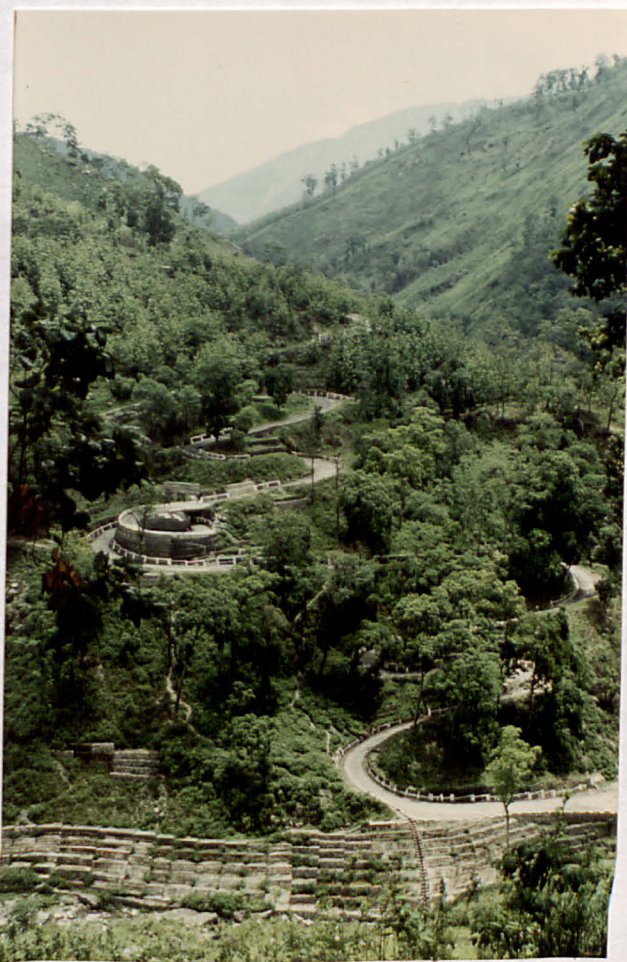
PLATE 2.14 Hairpin Stack Along the Teesta-Darjeeling Road.

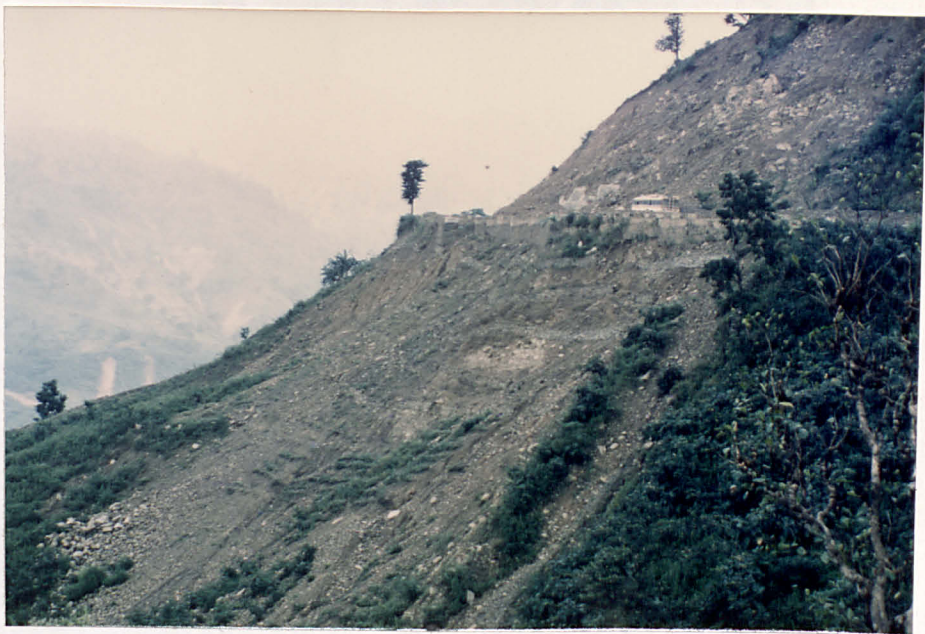
PLATE 2.15 Deep-Seated Rotational Failure at Km 4.100 on the Dharan-Dhankuta Road in September 1983.

On the northern side of the re-entrant, at km 4.100 from Dharan, deep-seated rotational failure in September 1983 resulted in the loss of approximately 60m of road line (Plate 2.15). Remedial works undertaken consisted, essentially, of site clearance, road excavation, disposal of spoil material, reconstruction of the gabion retained embankment, side drains and erosion protection works. The total costs (materials and labour) incurred in implementing these works are shown in Table 2.3. Measures designed specifically to increase the stability of this slope included the reconstruction of the checkdams in the gully at the base of the slope, and dry stone pitching¹ and contour wattling² of the back-

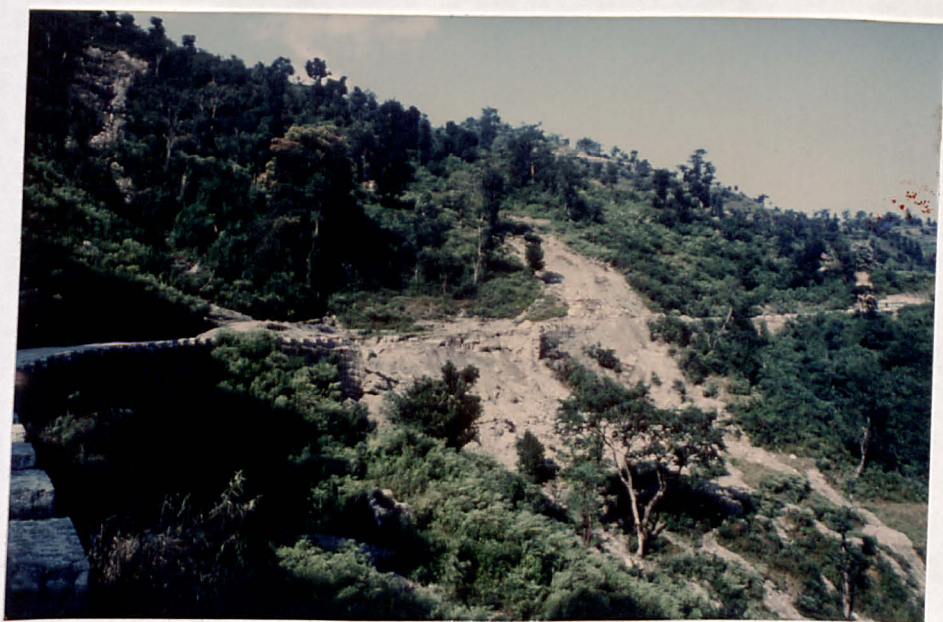
PLATE 2.16 Road Loss by Debris Flow at Km 23.400 on the Dharan-Dhankuta Road.

cause of road and culvert destruction (Plate 2.16, Appendix 1 A.6). Debris flow deposits were observed along many of the Himalayan roads visited, although their impact on these roads and associated structures was not seen to be as severe as that caused by deep-seated mass movements, as the majority occur in relatively large channels that have been either bridged or culverted.

Finally, at km 23.400 on the descent to the Leoti Khola floodplain, the passage of a debris flow through the central drainage channel of an unstable bowl in September 1984, caused road loss and destruction of the gabion retained embankment and erosion protection works below (Plate 2.16). Remedial works employed at this site have included the reconstruction of the road, on gabion retained embankment, pipe culvert and the erosion protection works in the gully below. These works have involved the construction of 6435.5 m³ of gabion, and the total cost of works at this site amounted to NCRs 2 827 406 (£117 809 prior to NCR devaluation). These figures can be compared with the overall cost of the construction of the Dharan-Dhankuta road (Table 2.5). Items in this table applicable to the works carried out at the sites mentioned above (access and site clearance, earthworks, construction of retaining walls, side drains, area drainage and stability, protection of side slopes and masonry and gabion revetments) amounted to £6 559 311 for the whole road or, on average, £12 978 per 100m.

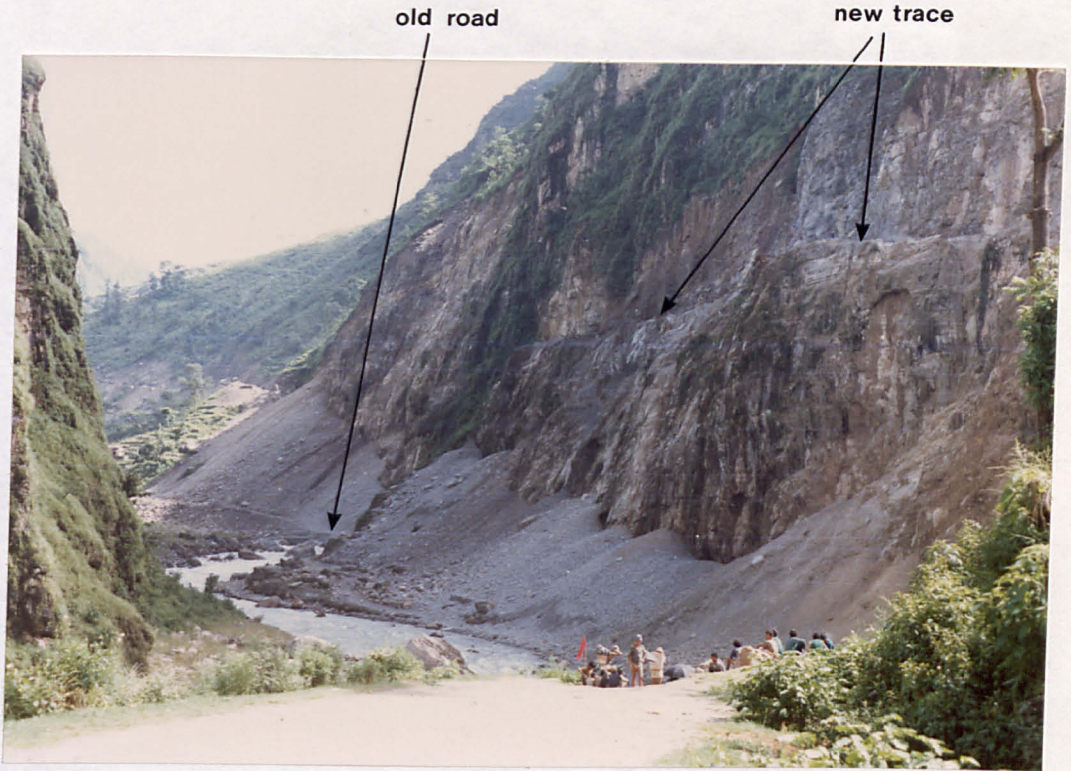
PLATE 2.17 Location of the Kathmandu- Kodari Road in the Engorged Bhote Kosi Valley. (Following Removal of the Road by Flooding, the Alignment has been Relocated Further up the Gorge Flank in Full Cut).

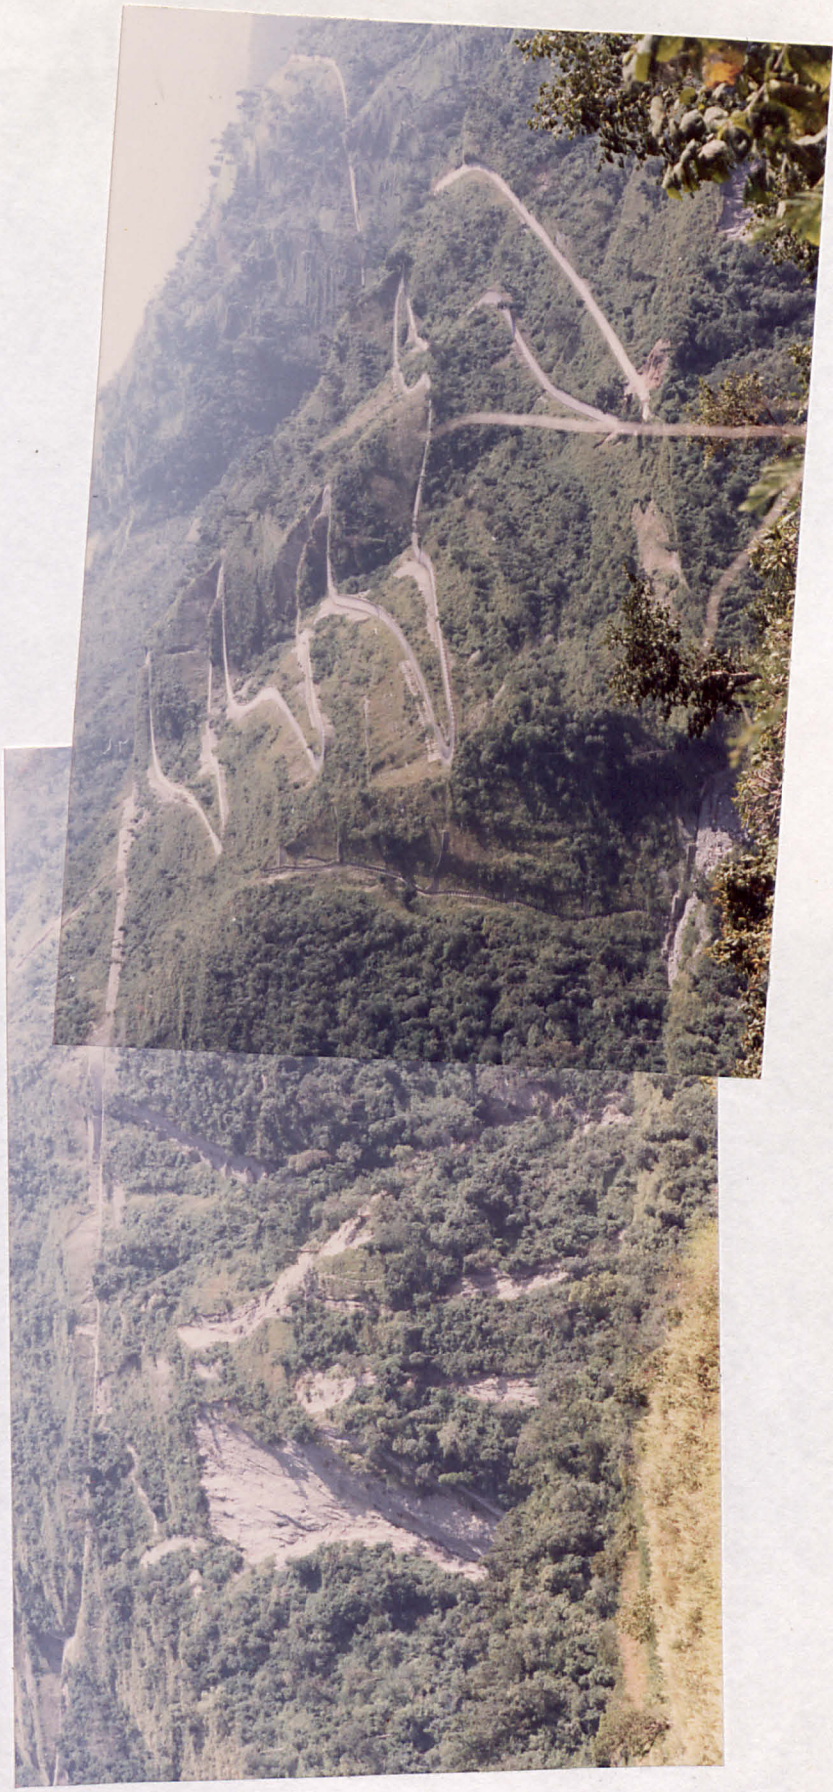
PLATE 3.1 Ascent to the Sangure Ridge Via the Kumlintar Hairpins.

From Dharan (400 m asl), the Dharan-Dhankuta road ascends the Sangure Ridge to a height of 1420 m asl via a series of contour traverses, and vertical and offset hairpin stacks across complex valley re-entrants and side-long ground (Plate 3.1). Crossing the ridge, the road descends into the Leoti Khola valley, again via a complex arrangement of offset hairpin stacks, and traverses across side-long ground (Plate 3.2). Reaching the Leoti Khola floodplain, the road runs along the western bank before crossing the river to follow its eastern bank to the confluence with the Tamur River (Figure 3.3) at approximately 300 m asl. After bridging the Tamur, the road ascends the northern flank of the Tamur valley above Mulghat via a dramatic vertical hairpin stack (Plate 4.2),

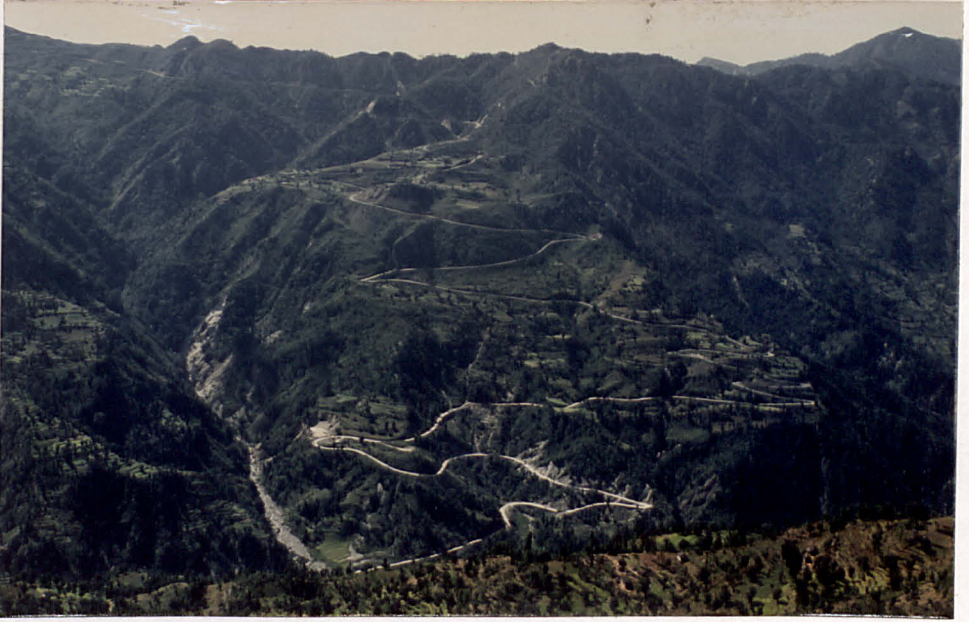
PLATE 3.2 Descent from the Sangure Ridge to the Leoti Khola Floodplain.

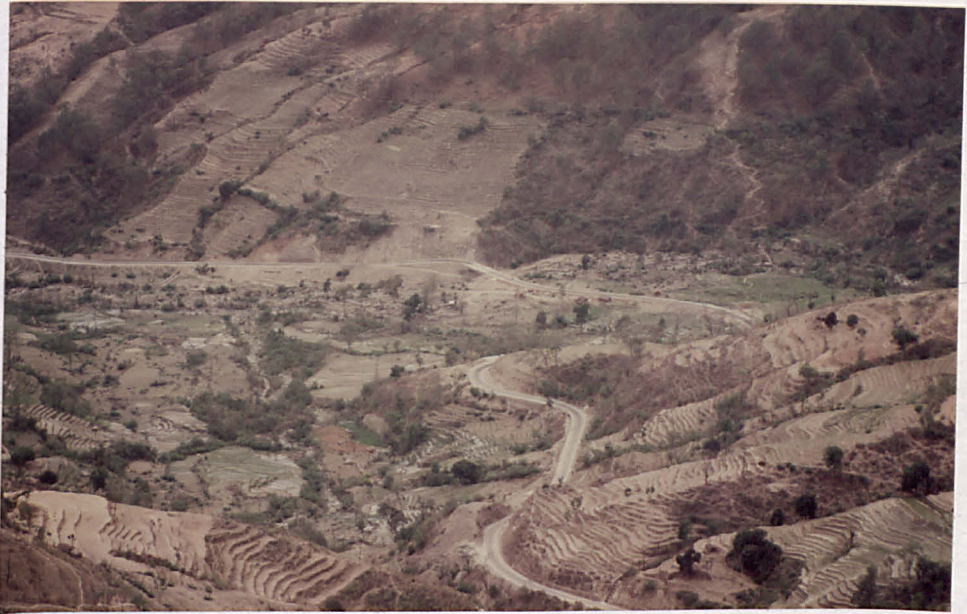
PLATE 3 .3 Traverse Across Shallowly Inclined Slopes of the Upper Dhankuta Khola.

before traversing northwards across the middle slopes of the Dhankuta Khola valley immediately above its incised gorge. Finally, the alignment crosses the headwaters of the Dhankuta Khola (Plate 3.3) and climbs steadily to Dhankuta. A full description of the alignment is given in Appendix 1.

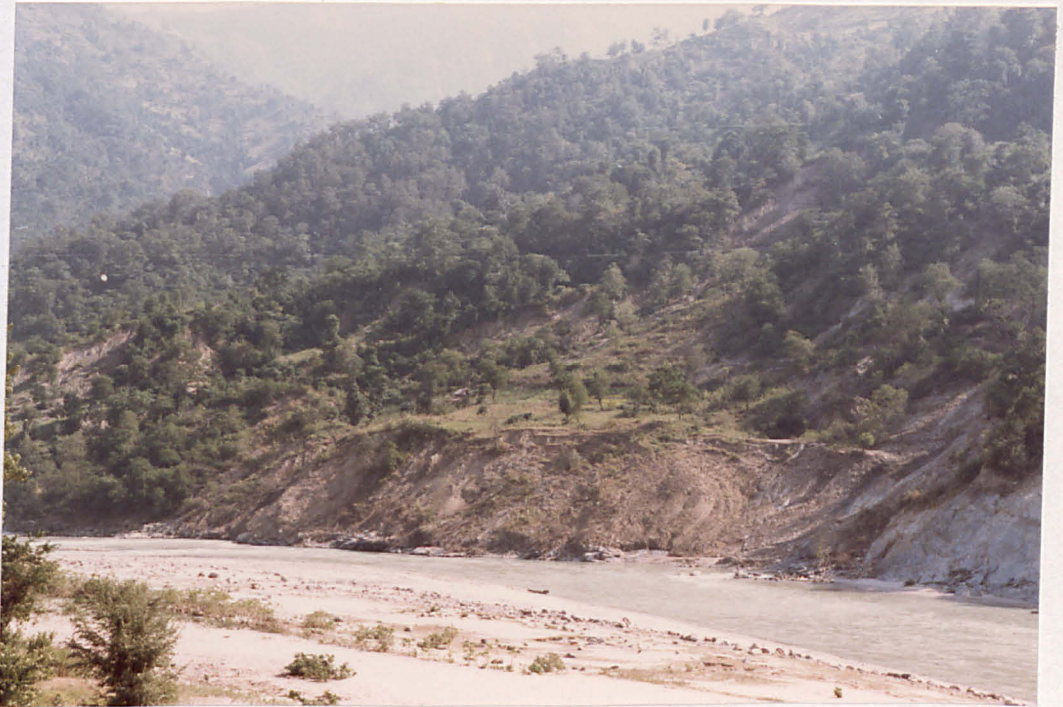
PLATE 3.5 Rotational Failure on the Southern Flank of the Tamur Valley, Reactivated During the September 1984 Storm.

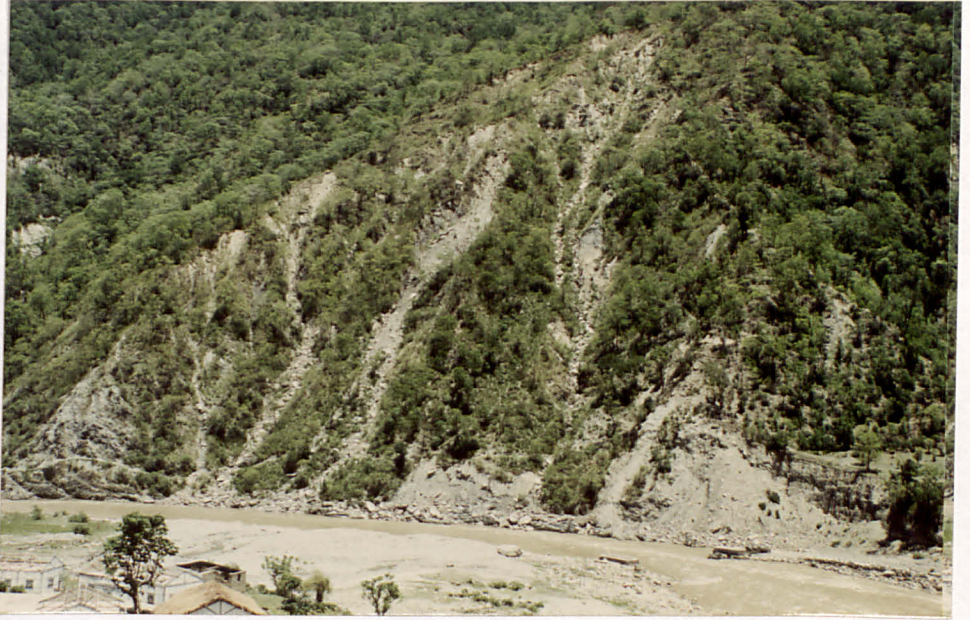
PLATE 4.1 Unstable Incised Flank of the Tamur Valley, Crossed by the Proposed RTO Line at Mulghat.

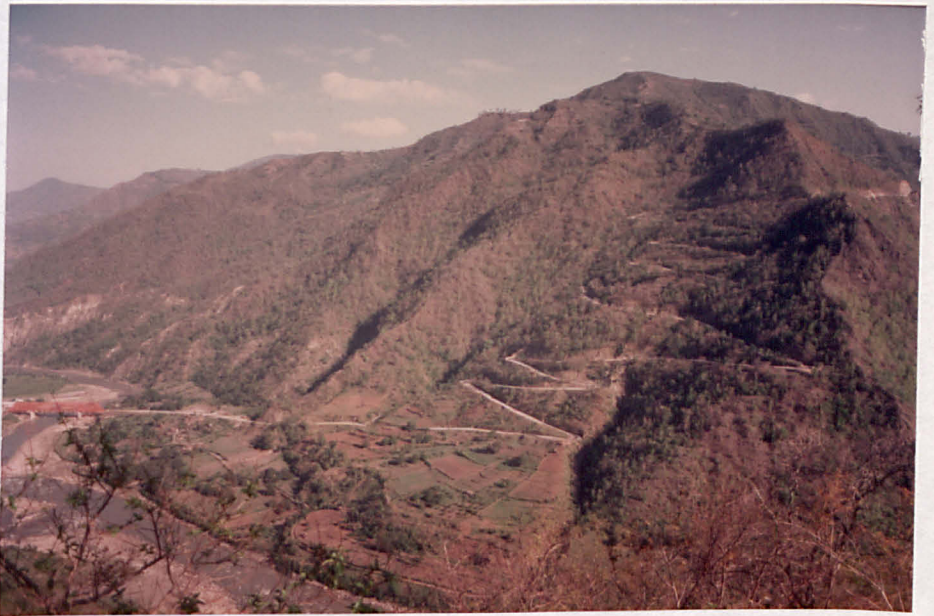
PLATE 4.2 Vertical Hairpin Stack at Mulghat.

A critical appraisal of this survey is given in the following section. Suffice to note here that the geomorphologists recognised that the incised and oversteepened lower and middle valley-side slopes, crossed by the majority of the COALMA line, posed the highest potential for instability. Although the eastern flanks of the Leoti Khola and the traverse above the Dhankuta Khola gorge were judged to be the most hazardous and unacceptable sections of the alignment, the geomorphologists confirmed that the whole route should be rejected. As an alternative, GSI proposed an alignment concept that avoided the unstable lower and middle slopes by gaining elevation in hairpin stacks, located on relatively stable slopes, and distance along ridge-tops or on valley floors. This design philosophy is reflected in the final design of the alignment, of which hairpin stacks form a conspicuous part (Plate 4.2).

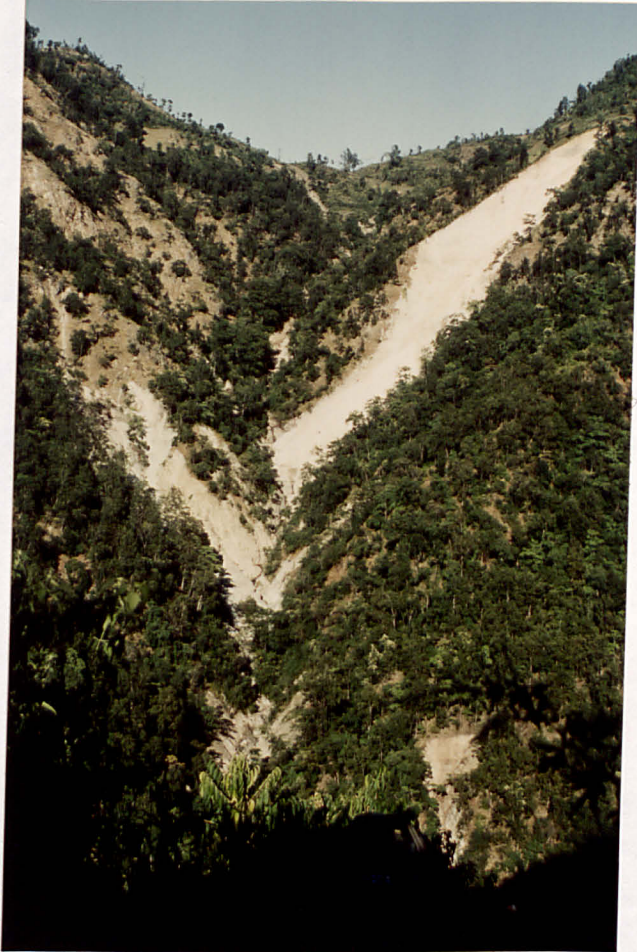
PLATE 4.3 Rock Slide in Quartzite Along the COALMA Line,
Initiated During the 1983 Monsoon.

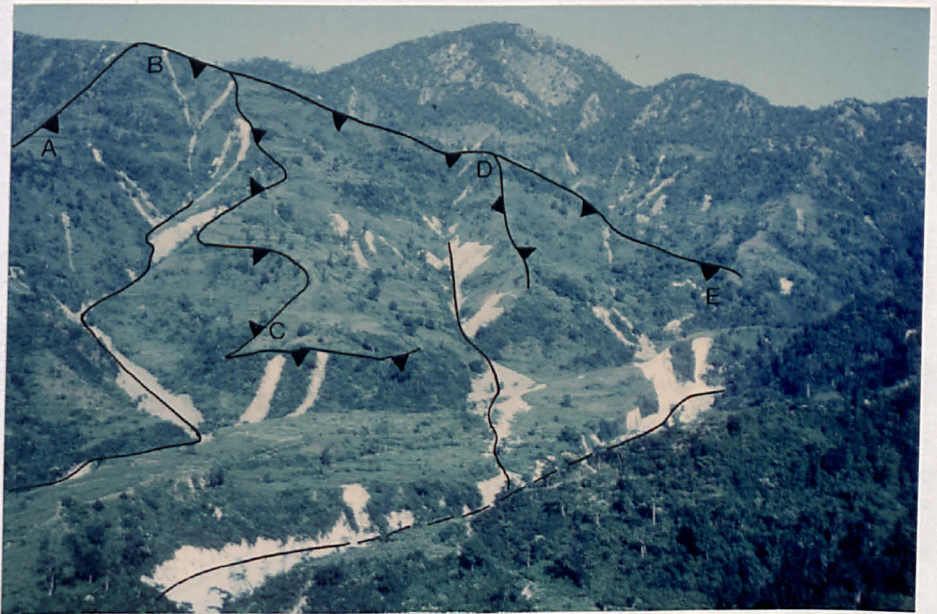
PLATE 4.5 Slopes Crossed by the COALMA Line on the Western Flanks of the Sardu Khola:Post-1984 Storm.

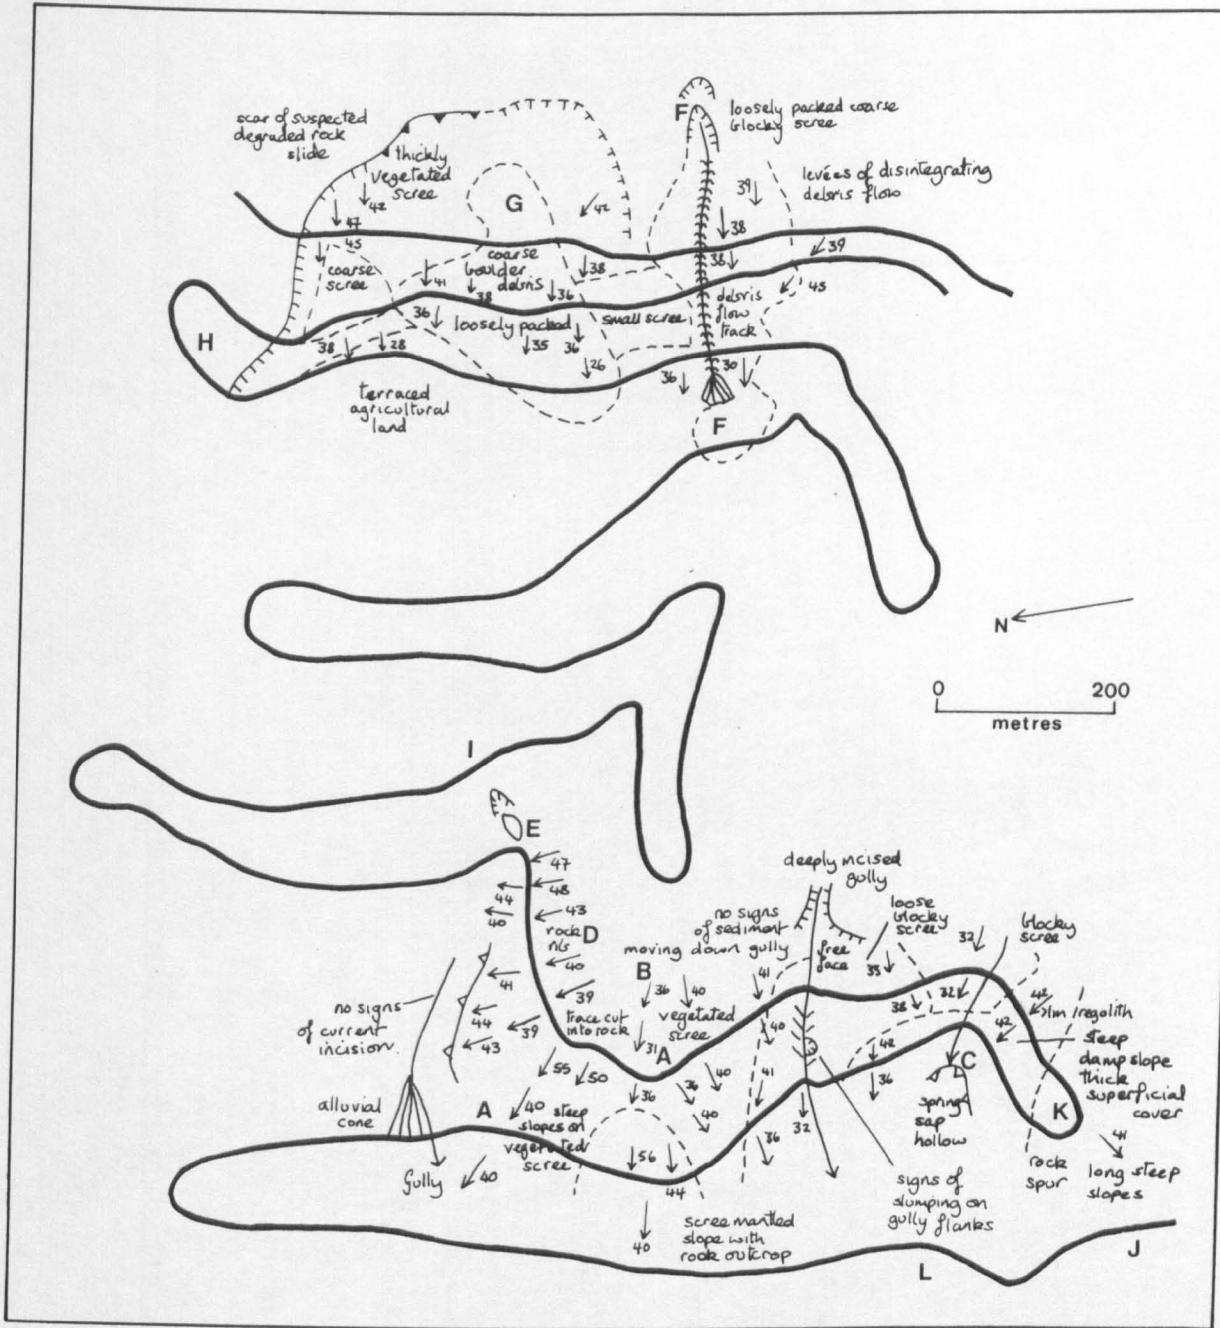
FIGURE 4.4 Geomorphological Map(GS 2) of the Kumlintar Hairpins.

The Kumlinter hairpins form one of the two vertical hairpin stacks along the road. A full description of slope conditions at this site, the road design and present stability is presented in Appendix 1A.4 . Details of the observations and recommendations made by the reconnaissance surveys, and the design and present stability of the road, are given in Table 4.4. The geomorphological strip map produced by GS2 is reproduced in Figure 4.4.

A large ancient rock slide (G), of possible earthquake origin, was identified by GS2 at the top of the hairpin stack (Figure 4.4). Although the antiquity of this rock slide was recognised, it was recommended that drainage of the slip material, above the trace, be undertaken. In addition, GS2 suggested that the

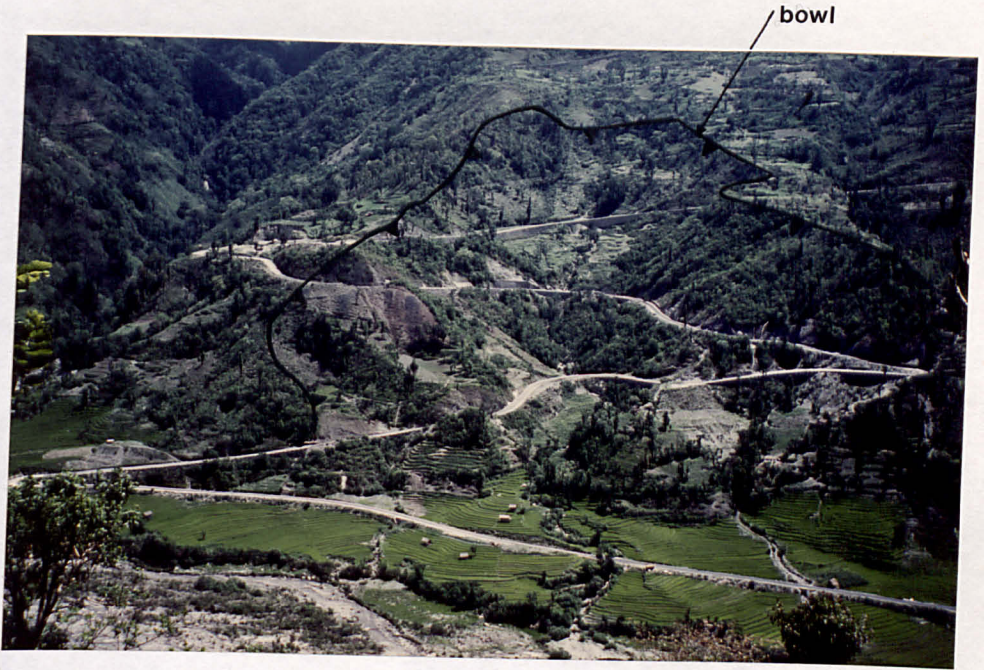
PLATE 4.6 Triple Crossing of an Unstable Bowl Depression on the Lower Flanks of the Leoti Khola Valley.

The final few kilometres of descent to the Leoti Khola floodplain, on the steepened lower valley side slopes (Plate 4.6), involves the triple crossing of a large bowl-shaped catchment that is characterised by mass movements, boulder fan accumulations and a drainage system that has become incised into both colluvium and weathered phyllite and paper shale. A full description of the geomorphological character of this section, along with relevant details of road design and present stability, is given in Appendix 1A.6. The observations and recommendations made by GS2 and EG1, and details of the final design and present stability, are shown in Table 4.5. The geomorphological map produced by GS2 is reproduced in Figure 4.6.
