**AN EVALUATION OF GEOMORPHOLOGICAL CONTRIBUTIONS
TO MOUNTAIN HIGHWAY DESIGN WITH PARTICULAR
REFERENCE TO THE LOWER HIMALAYAS**

A thesis submitted for the degree of Doctor of Philosophy
in the University of London

Department of Geography
London School of Economics
and Political Science

February 1987

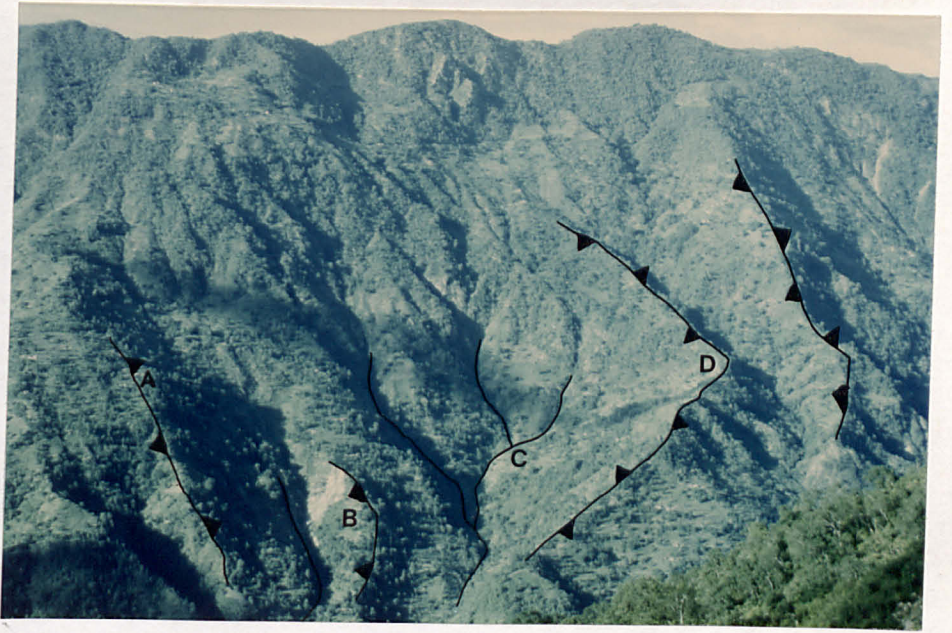
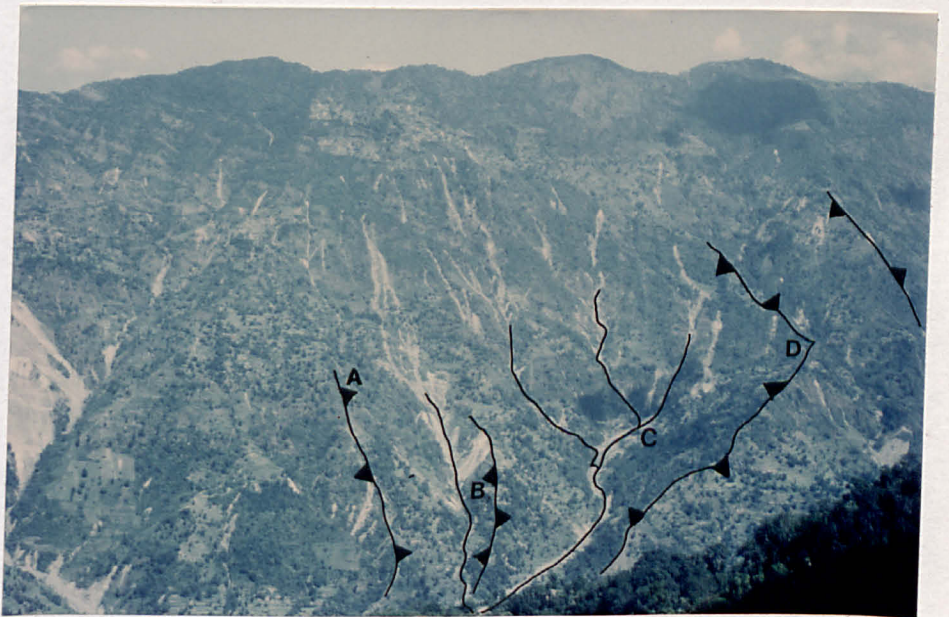
PLATES 5.1 and 5.2 The Extent of Erosion and Instability on the Northern Flanks of the Leoti Khola Valley Before and After the September 1984 Storm.

Precipitation, insolation, drainage and erosion comprise the main components of the Hydrology category. Slope instability in the study area often occurs in response to the development of high groundwater levels, combined with slope undercutting and oversteepening due to channel erosion (Chapter 3). Quite often, maximum rainfall intensities and soil permeability determine the potential for the development of high pore pressures and instability in shallow soils (Okuda *et al* 1980, Anderson and Howes 1985), rather than the delayed response of the water table at depth. Linear erosion usually occurs under similar conditions, and often forms headward extensions to eroding channels and landslides in unstable catchments, as channel incision and mass movement activity progress upstream as "waves of aggression" (Brunsdon *et al* 1981, p37) during high magnitude storms. Plates 5.1 and 5.2 demonstrate the extent of linear erosion and shallow landsliding on the northeastern flanks of the Leoti Khola valley caused by the storm of September 1984.

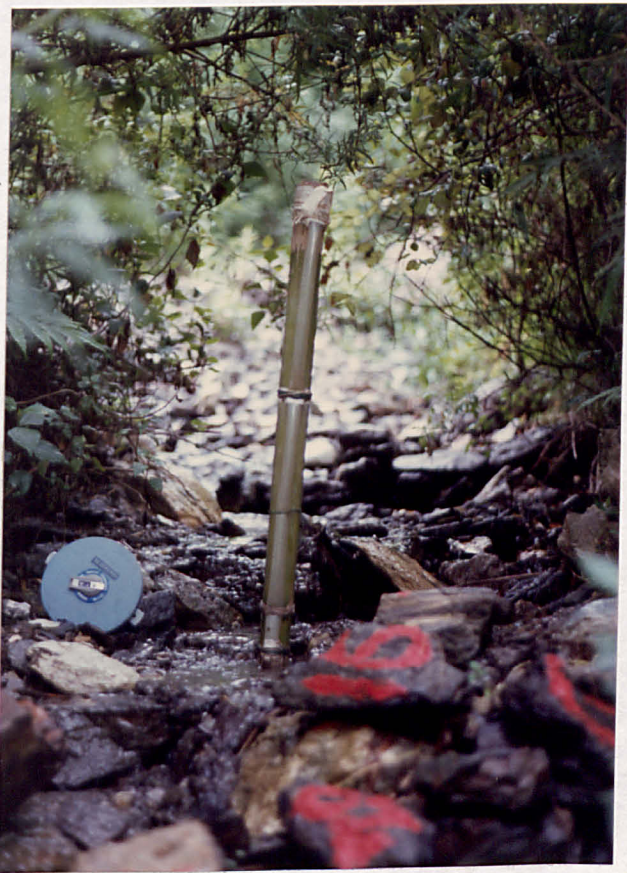
FIGURE 8.2 and PLATE 8.1 The Crest-Stage Recorder

A relatively stable reach was chosen upstream of the bridge or culvert in each channel. The cross-section was surveyed using a 30m tape to measure channel width combined with vertical depth-to-channel bed measurements. A crest-stage recorder was installed in each channel at the measured station to determine peak flow depth. The recorder (Plate 8.1, Figure 8.2) consisted of a 2m length of bamboo, approximately 5 cm in diameter with an equivalent length of transparent, flexible plastic pipe strapped to it. The bamboo was concreted into the channel bed, in an upright position. A piece of stocking was stretched over the lower orifice of the pipe and secured to it with string, wire and masking tape. Powdered cork was sprinkled into the pipe, and made to rest on the stocking gauze, to a depth of approximately 5mm. The top of the pipe was then covered with tape (though not made airtight) to prevent the ingress of rainwater. A gap of approximately 100mm was left between the base of the pipe and the stream bed to discourage the siltation and blocking of the gauze during low flow. The philosophy behind the design of the instrument was that a ring of cork would remain around the inside of the pipe as channel flow receded from peak stage.

Unfortunately, the crest-stage recorders were ineffective in recording peak stage levels. In Nishane Khola (the gully characterised by debris flow activity) and Kharane Khola, the instruments and their foundations were removed during the storms of 12 May and 14/15 July, respectively. The crest-stage recorder in Garjuwa Khola, was almost covered by channel aggradation during the 12 May storm and subsequently removed by scour during the following storm.

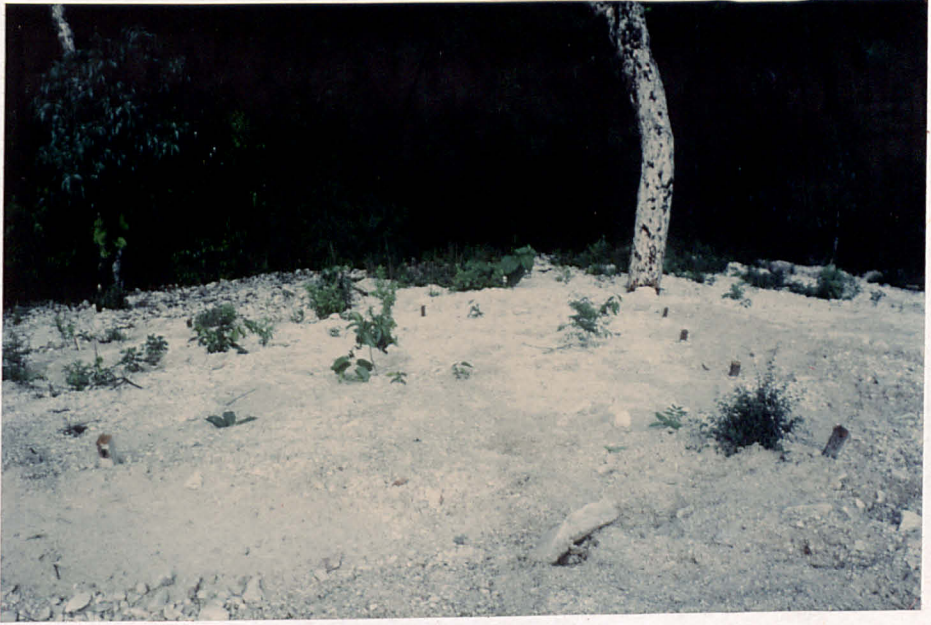
PLATE 8.3 The Monitored Tip Slope in Quartzite.

Field monitoring was undertaken during the monsoon season of 1984. In order to minimise the influence of variable rainfall intensity and depth, three monitoring sites were chosen in close proximity to one another, on the northern flanks of the crest of the Sangure Ridge (Figure 8.1). One of these slopes is formed in quartzite, while the other two are composed of phyllite. The quartzite slope (Plate 8.3) has an inclination of $36^{\circ}50'$ and an aspect of $080^{\circ}N$. Bedrock exposed in the cut slope is relatively massive white quartzite and is overlain by a thin, up to 20 cm deep, sandy, gravelly soil. The two phyllite slopes, hereafter referred to as Phyllite 1 (Plate 8.4) and Phyllite 2 (Plate 8.5), are inclined at $39^{\circ}40'$ and $37^{\circ}10'$ respectively, and both are oriented due north. In both cases, regolith is composed of a loose, silty clay with weathered phyllite gravel and cobbles, 30-60cm deep, overlying jointed phyllite, dipping obliquely out of the slope. Phyllite 1 has only been partially affected by spoil disposal from the Bhedetar-Rajarani road and displays a discontinuous vegetation cover, while Phyllite 2 had been totally laid bare by spoil disposal.

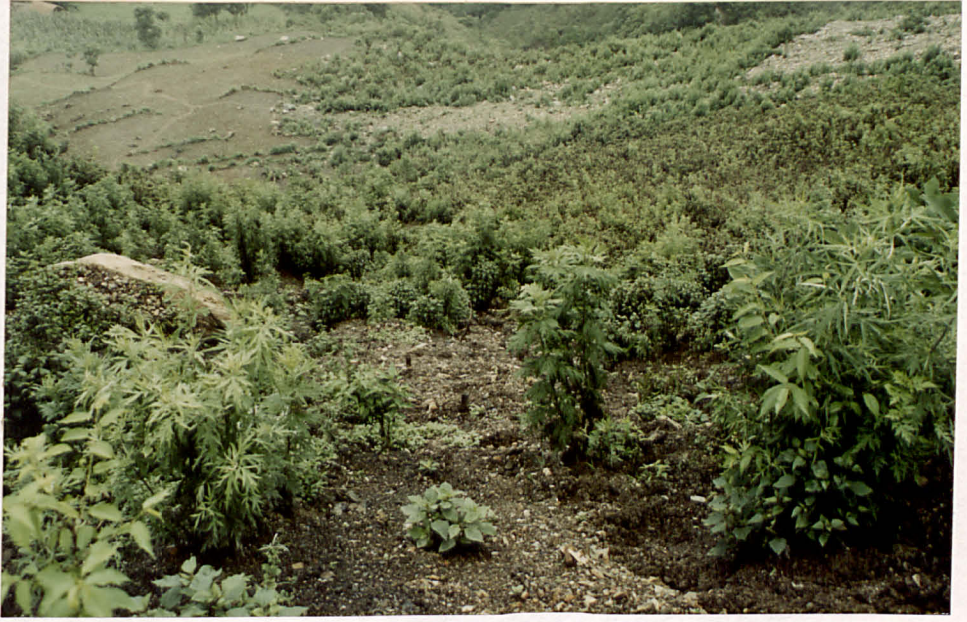
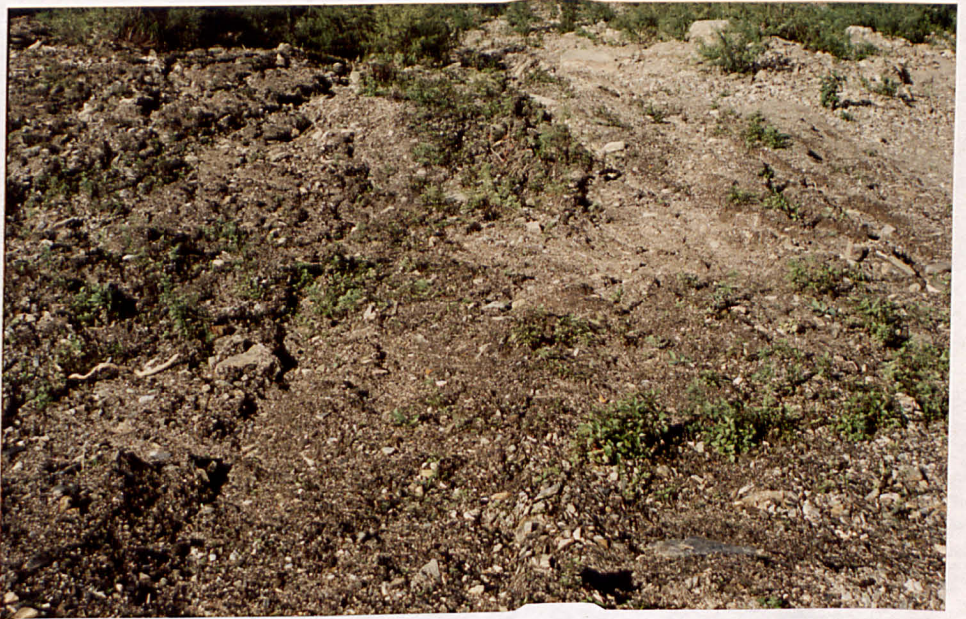
PHYLLITE 1

PHYLLITE 2

PLATES 8.4 and 8.5 The Two Monitored Tip Slopes in Phyllite.

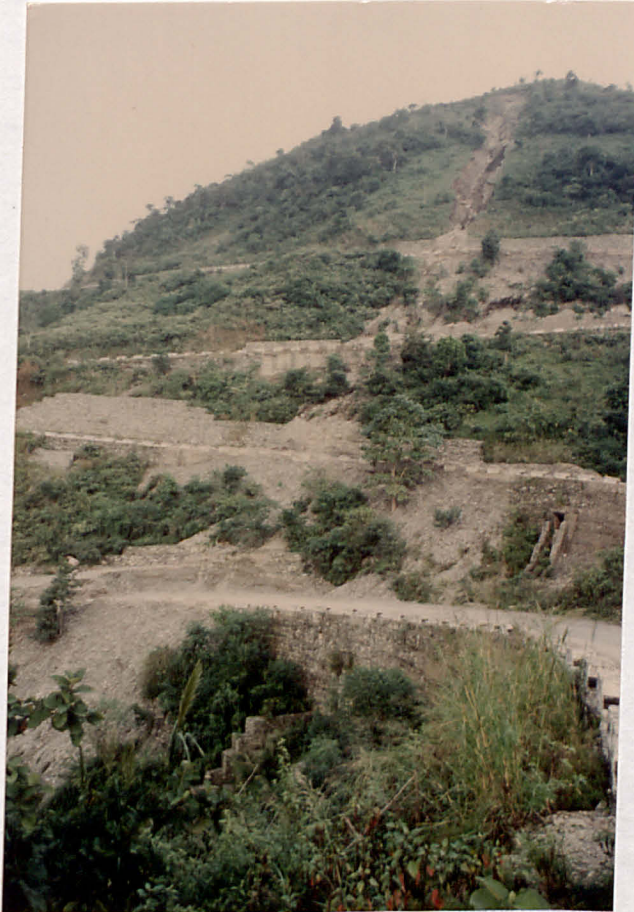
PLATE A.2 Debris Flow Deposits on the Kumlintar Hairpins.

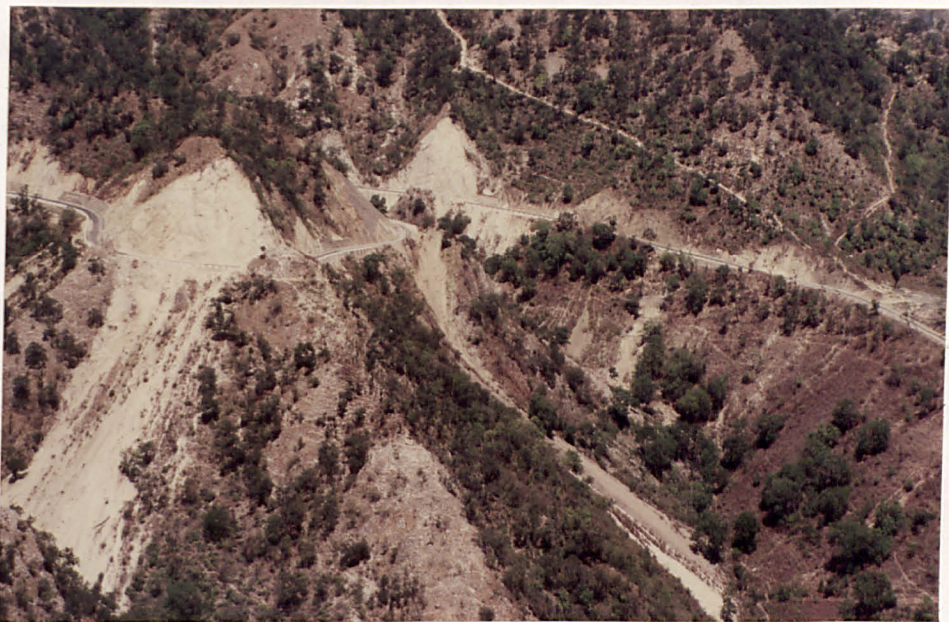
PLATE A.3 Road Alignment Across the Quartzite Slopes Below the Sangure Ridge, Showing the Extent of Spoil Tipping.

Between km 14.200 and km 17.500, the road is excavated mainly in full-cut, through quartzite (Plate A.3). The quartzite structure is dominated by joint planes that dip at up to 50° in a direction that is approximately to the north, and frequently out of the cut slope. Despite these often adverse structural conditions, cut slopes have been excavated successfully to 70° or more.

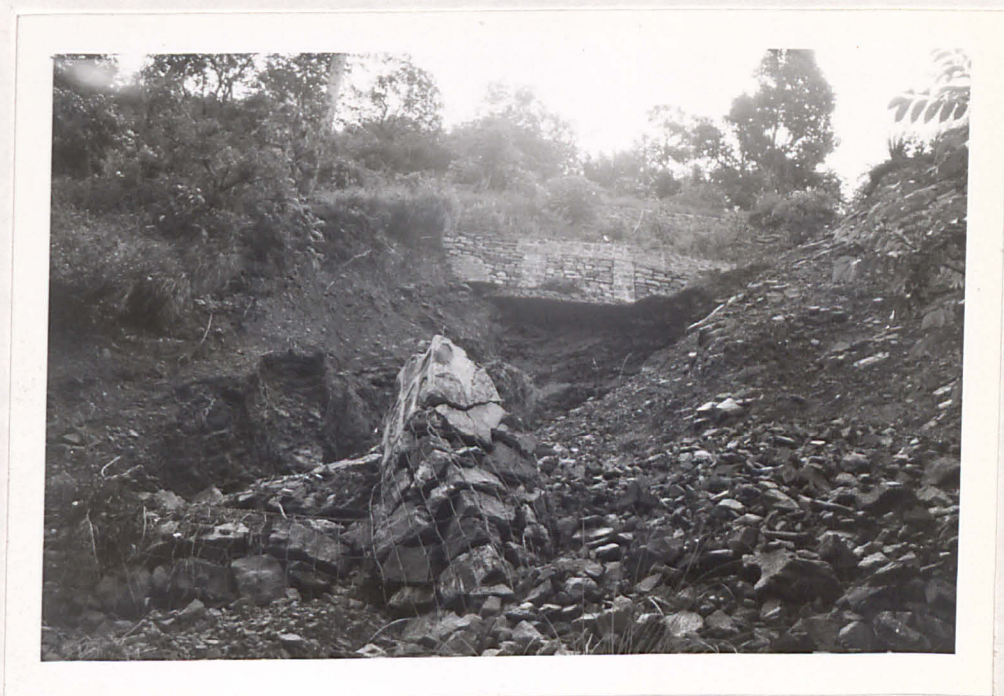
PLATE A.4 Erosion Below Side Drain Exit on the Descent to the Leoti Khola Floodplain.

Probably the most outstanding feature of contemporary slope erosion along this section is the instability taking place below side drain exits. At these locations, concentrated storm runoff from the road surface is discharged onto the slopes below, and extensive erosion has resulted. Slope protection works, in the form of masonry and gabion cascades and mattresses, have been severely damaged (Plate A.4). Although this poses no direct threat to the road itself, it has caused localised slope and drainage instability in the catchments below.

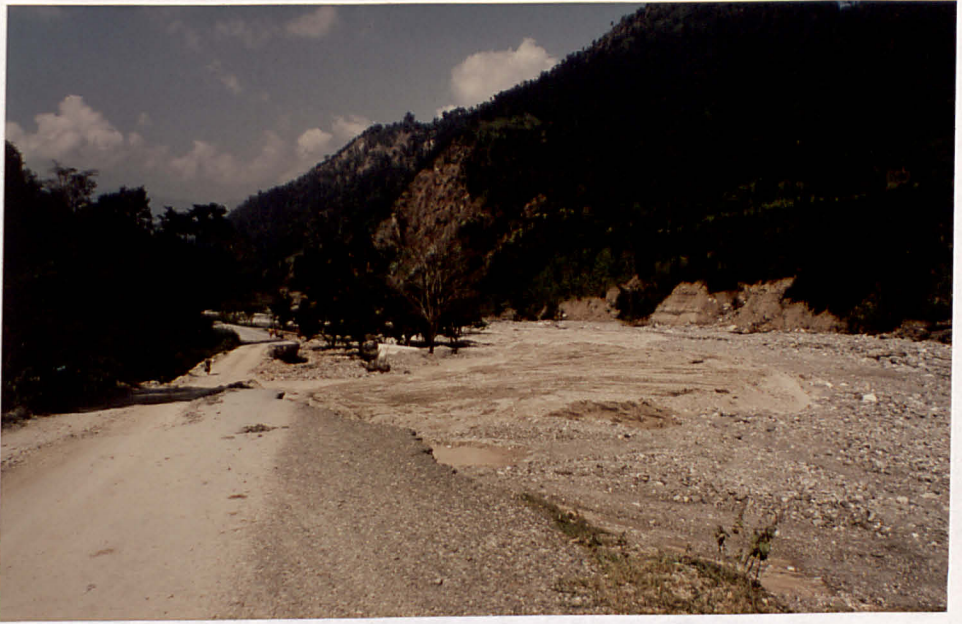
PLATE A.5 Partial Burial by Sediment of the Road Camp at Phalametar, on the Leoti Khola Floodplain.

The storm caused extensive flooding in the Leoti Khola, resulting in major road loss and damage to protection works and fan crossings. Major road loss occurred at six main localities (Figure A.5): km 26.730 - 900, km 27.000, km 27.150 - 260, km 27.960 - km 28.200, km 31.770 - 790 and km 32.300 -370. In addition, the falling apron was damaged or removed along a significant proportion of the embanked sections. A gabion groyne, constructed in 1983 in the Phalametar gorge, was totally destroyed along with another at km 28.100. A third groyne at km 28.220, was severely damaged. Terrace bank protection works, immediately upstream of Phalametar, were removed, while the road camp constructed on the floodplain was buried in sediment (Plate A.5).

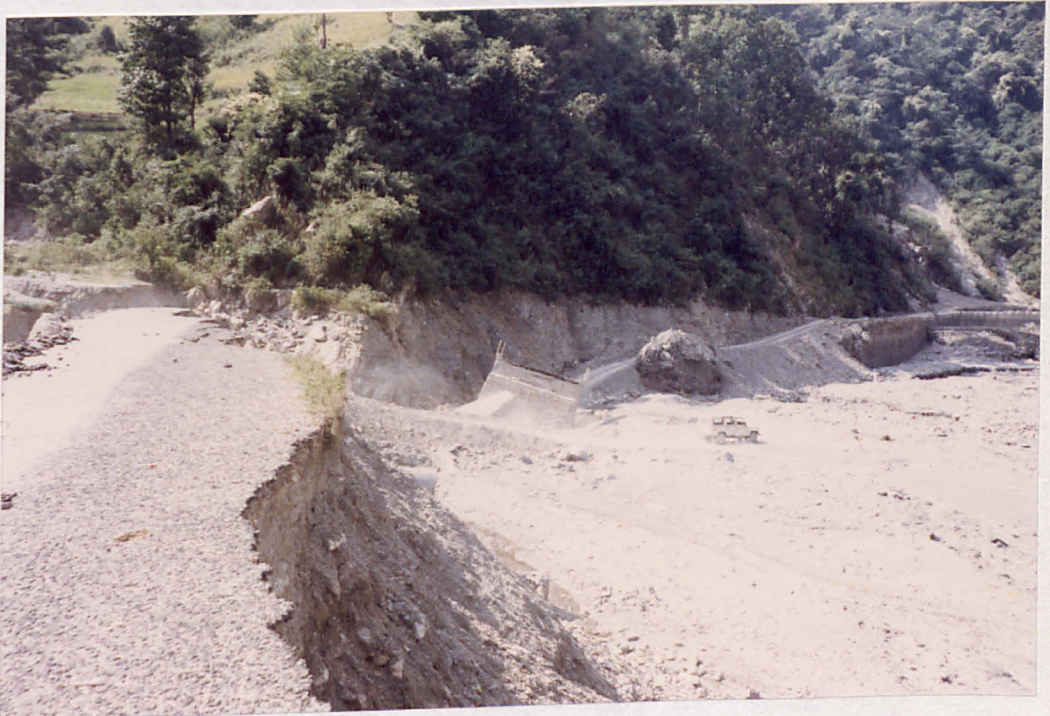
PLATE A.6 Road Loss at Km 28.100 on the Leoti Khola Floodplain.

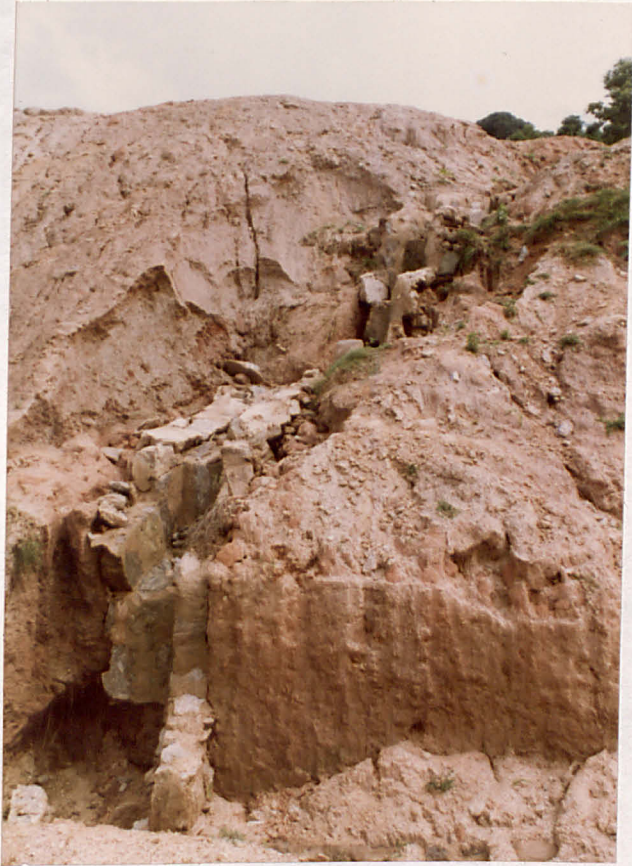
PLATE A.7 Undermining of Area Drainage by Erosion on the Gneiss Slopes Below Dhankuta.

Problems for road stability along this section relate to rapid sub-surface flow in the loose sandy regolith and shallow translational (rock) and rotational (soil) slope failures in road cuts. Extensive filter and cut-off drains have been installed behind the cut slopes to intercept both shallow sub-surface and overland flow, in order to prevent cut slope failure and erosion. However, many of the surface drains have been undermined (Plate A.7) and, in general, have had very little stabilizing influence.
